Retrospection of STS107 Crash: A Review From Forensic Engineering Perspective

ABSTRACT:

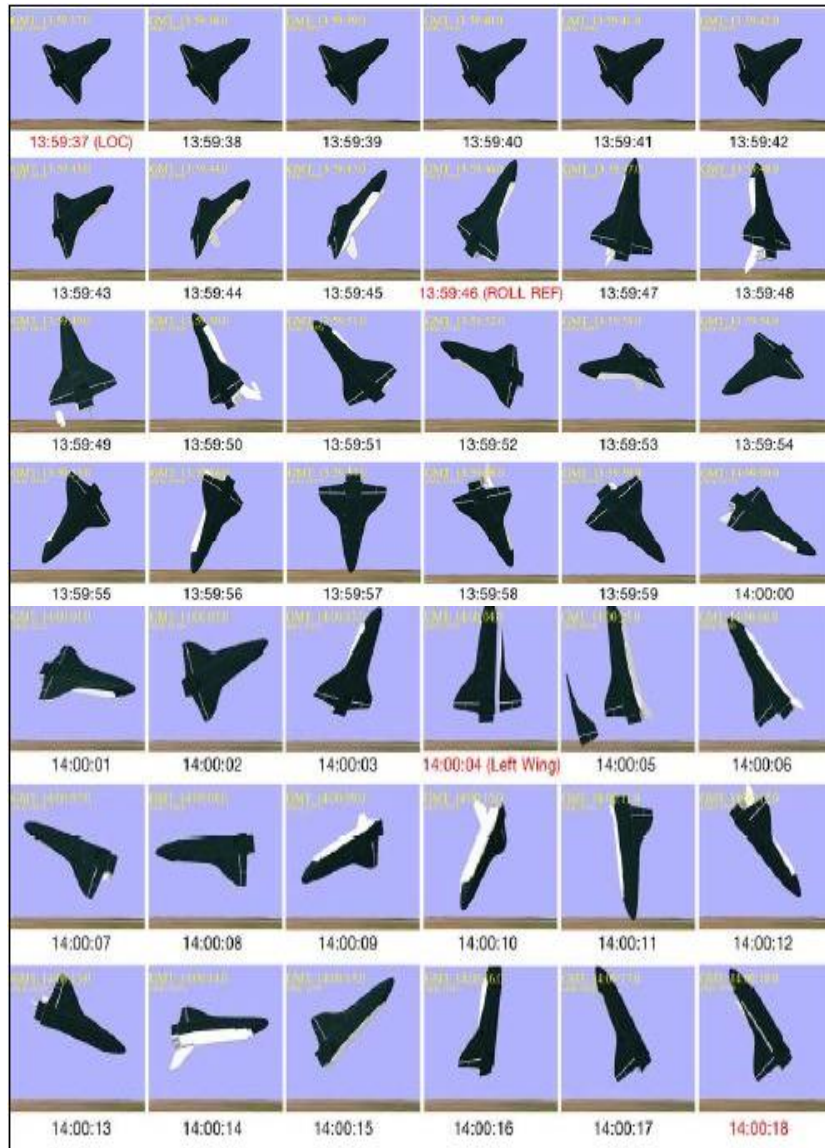
Figure-1: Entry simulation snapshot sequence

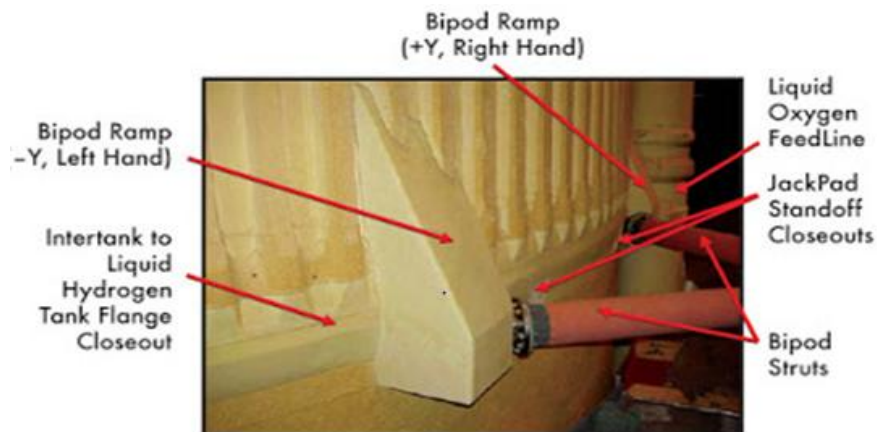
Figure 2: Figure showing bipod struts and its connection to external fuel tank

Early tests conducted by the investigation team suggested that as the shuttle launch system lifted off, the nose of the external tank remained relatively unaffected by the compression heating and stress. But just behind the nose of the tank, nearly around the point where the bipod strut connected the tank to the nose, immense shock waves were formed that created one of the major stressful environments and heat around the tank. Furthermore, airflow around the struts was complex and was capable of causing heat and stress. Initially it was assumed by NASA that the usual foam insulation around the struts would protect them but additional testing disapproved this notion^{[2][5]}.

After launch of STS-107 (Columbia) on January 16, 2003, a foam from the left bipod strut separated from the external tank and struck its left wing 81.9 seconds just after its lift-off. The cause of the left bipod foam ramp braking free still remains a mystery. Later image analysis showed that the piece of foam ranged roughly from 21 to 27 inches in length and 12 to 18 inches in width, and relatively thin^[3]. The foam travelled with the shuttle at about 1,568 mph. When the foam detached, it began to slow down (in part, because it was no longer powered, but also because its low density and shape shed energy and thus reduced its speed). Essentially, the orbiter ran into the foam at a relative velocity of about 545 mph. It is estimated that the foam made about 18 revolutions per second as it fell. Its trajectory was parallel to the shuttle's fuselage, at a 5 degree angle away from the external tank, and with a slight outboard movement. The actual orientation of the panel of foam to the wing at impact cannot be determined. The foam hit RCC panels 6-left through 9-left. As the shower of post-impact fragments could not be seen passing over the top of the wing, analysts later concluded that the debris had impacted the left wing below the leading edge^{[3][4]}. The debris impact was identified on January 17, the second day of the mission. That same day, an object - probably a piece of damaged RCC tile - drifted away from the orbiter. Although military radar observed the piece floating off, this was not discovered until after the accident.
