Four-Wheelerhealth Monitoring From Cabin and Pass-Bynoise Levels: Acase Study

Manpreet Singh*, Medisetty Venkata Manikanta*, Nihar Ranjan Swain*, Keshav Jha*, Shah Fiaz*, Rajeev Kumar*, Piyush Gulati*, Jaiinder preet Singh*, Sumit Shoor*, Hapreet Singh**

*School of Mechanical Engineering, Lovely Professional University, Phagwara, Punjab-144411

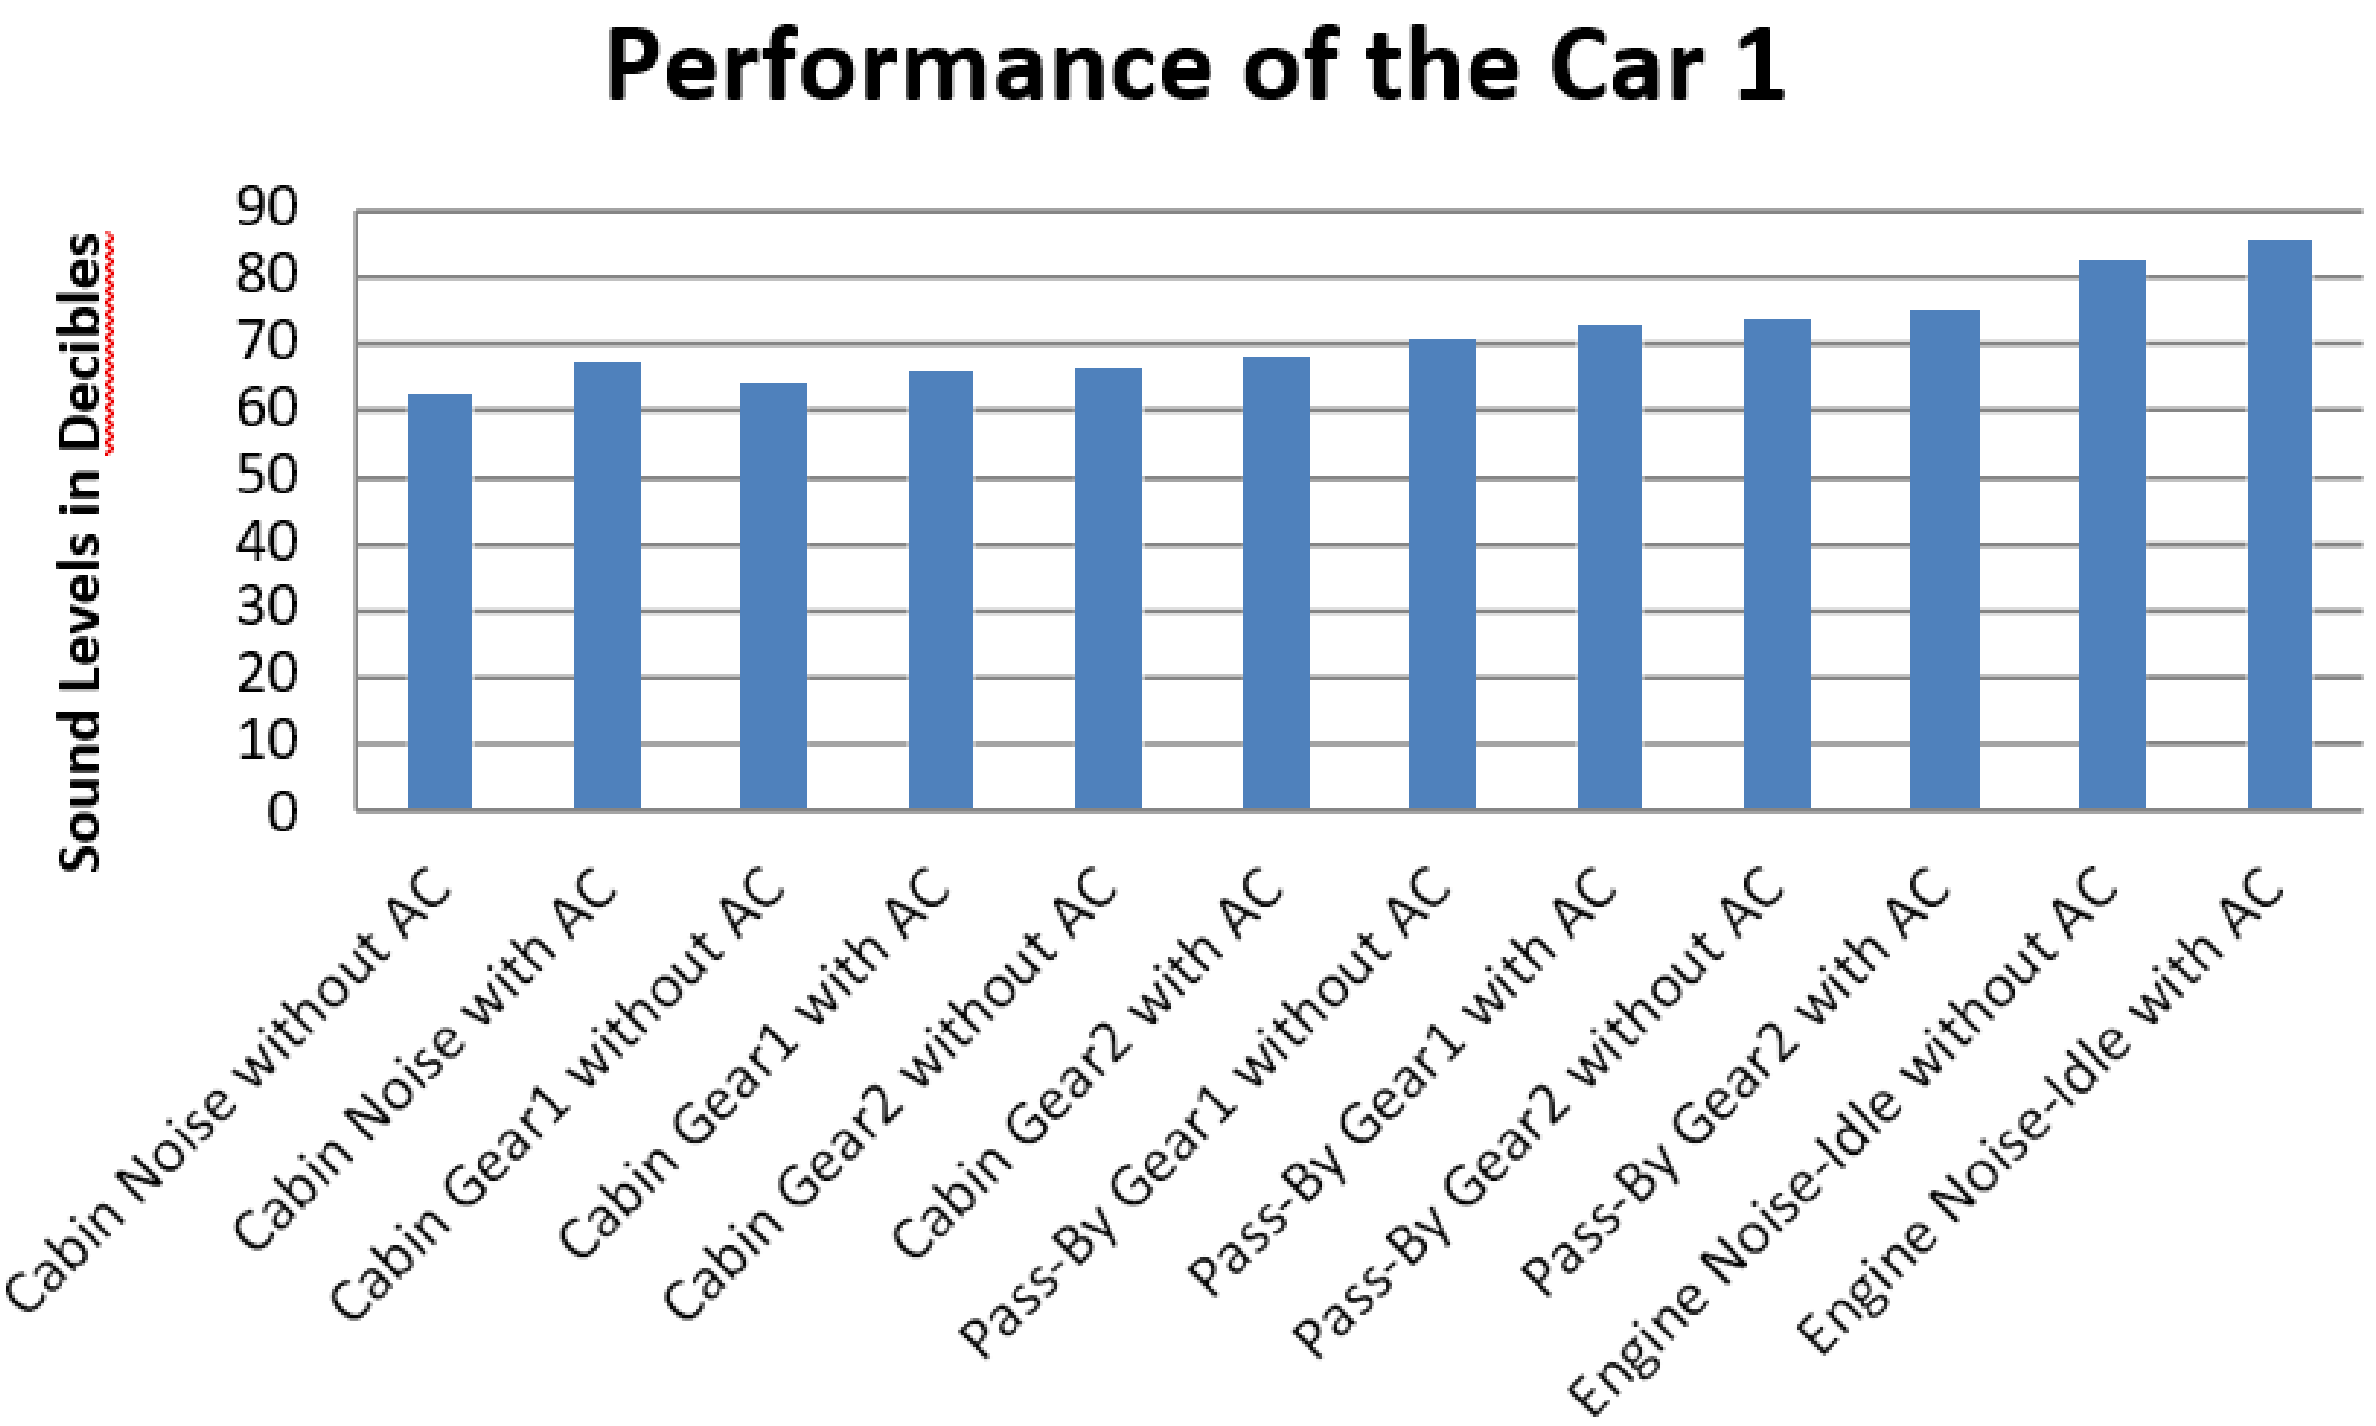
Figure 1: Sound level of Car 1 for all the conditions

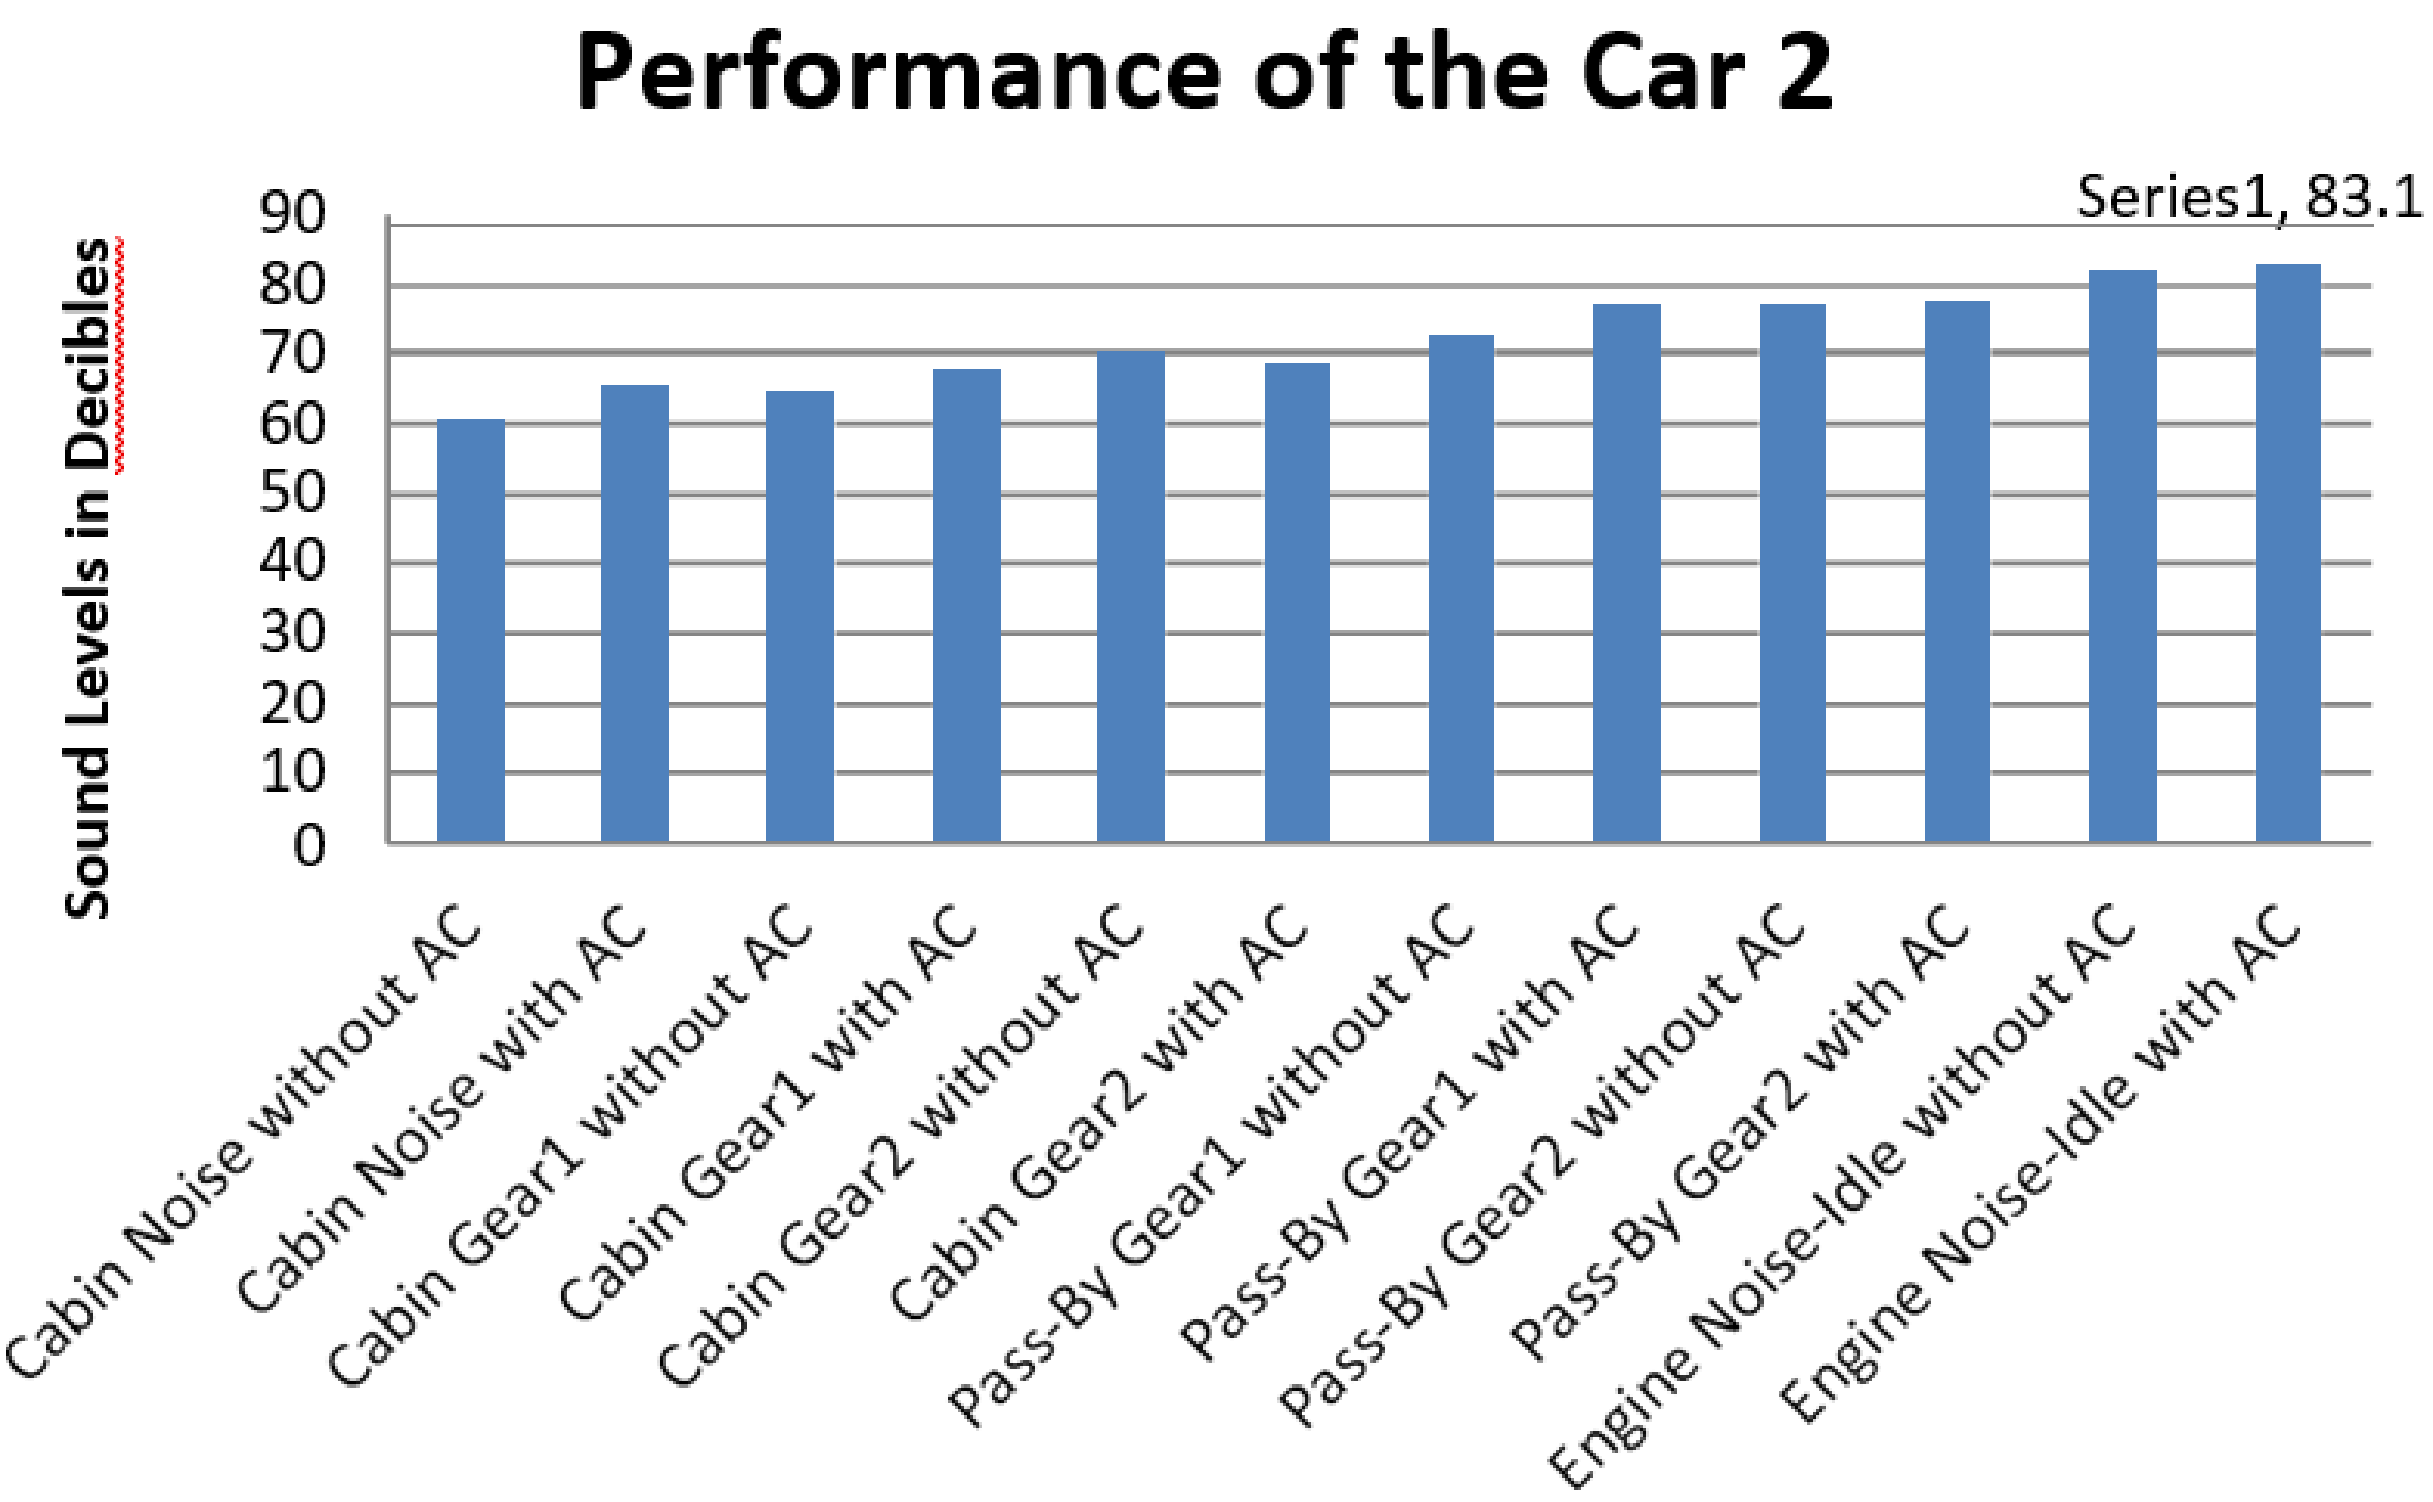
Figure 2: Sound level of Car 2 for all the conditions

3. The worn-out tires produce more sound compared to the normal tires and it can be identified from the recorded pass-by noise level. Also tire noise is having very little impact in the cabin as in Car 2 there is no impact of worn-out tires can be recorded in the cabin.

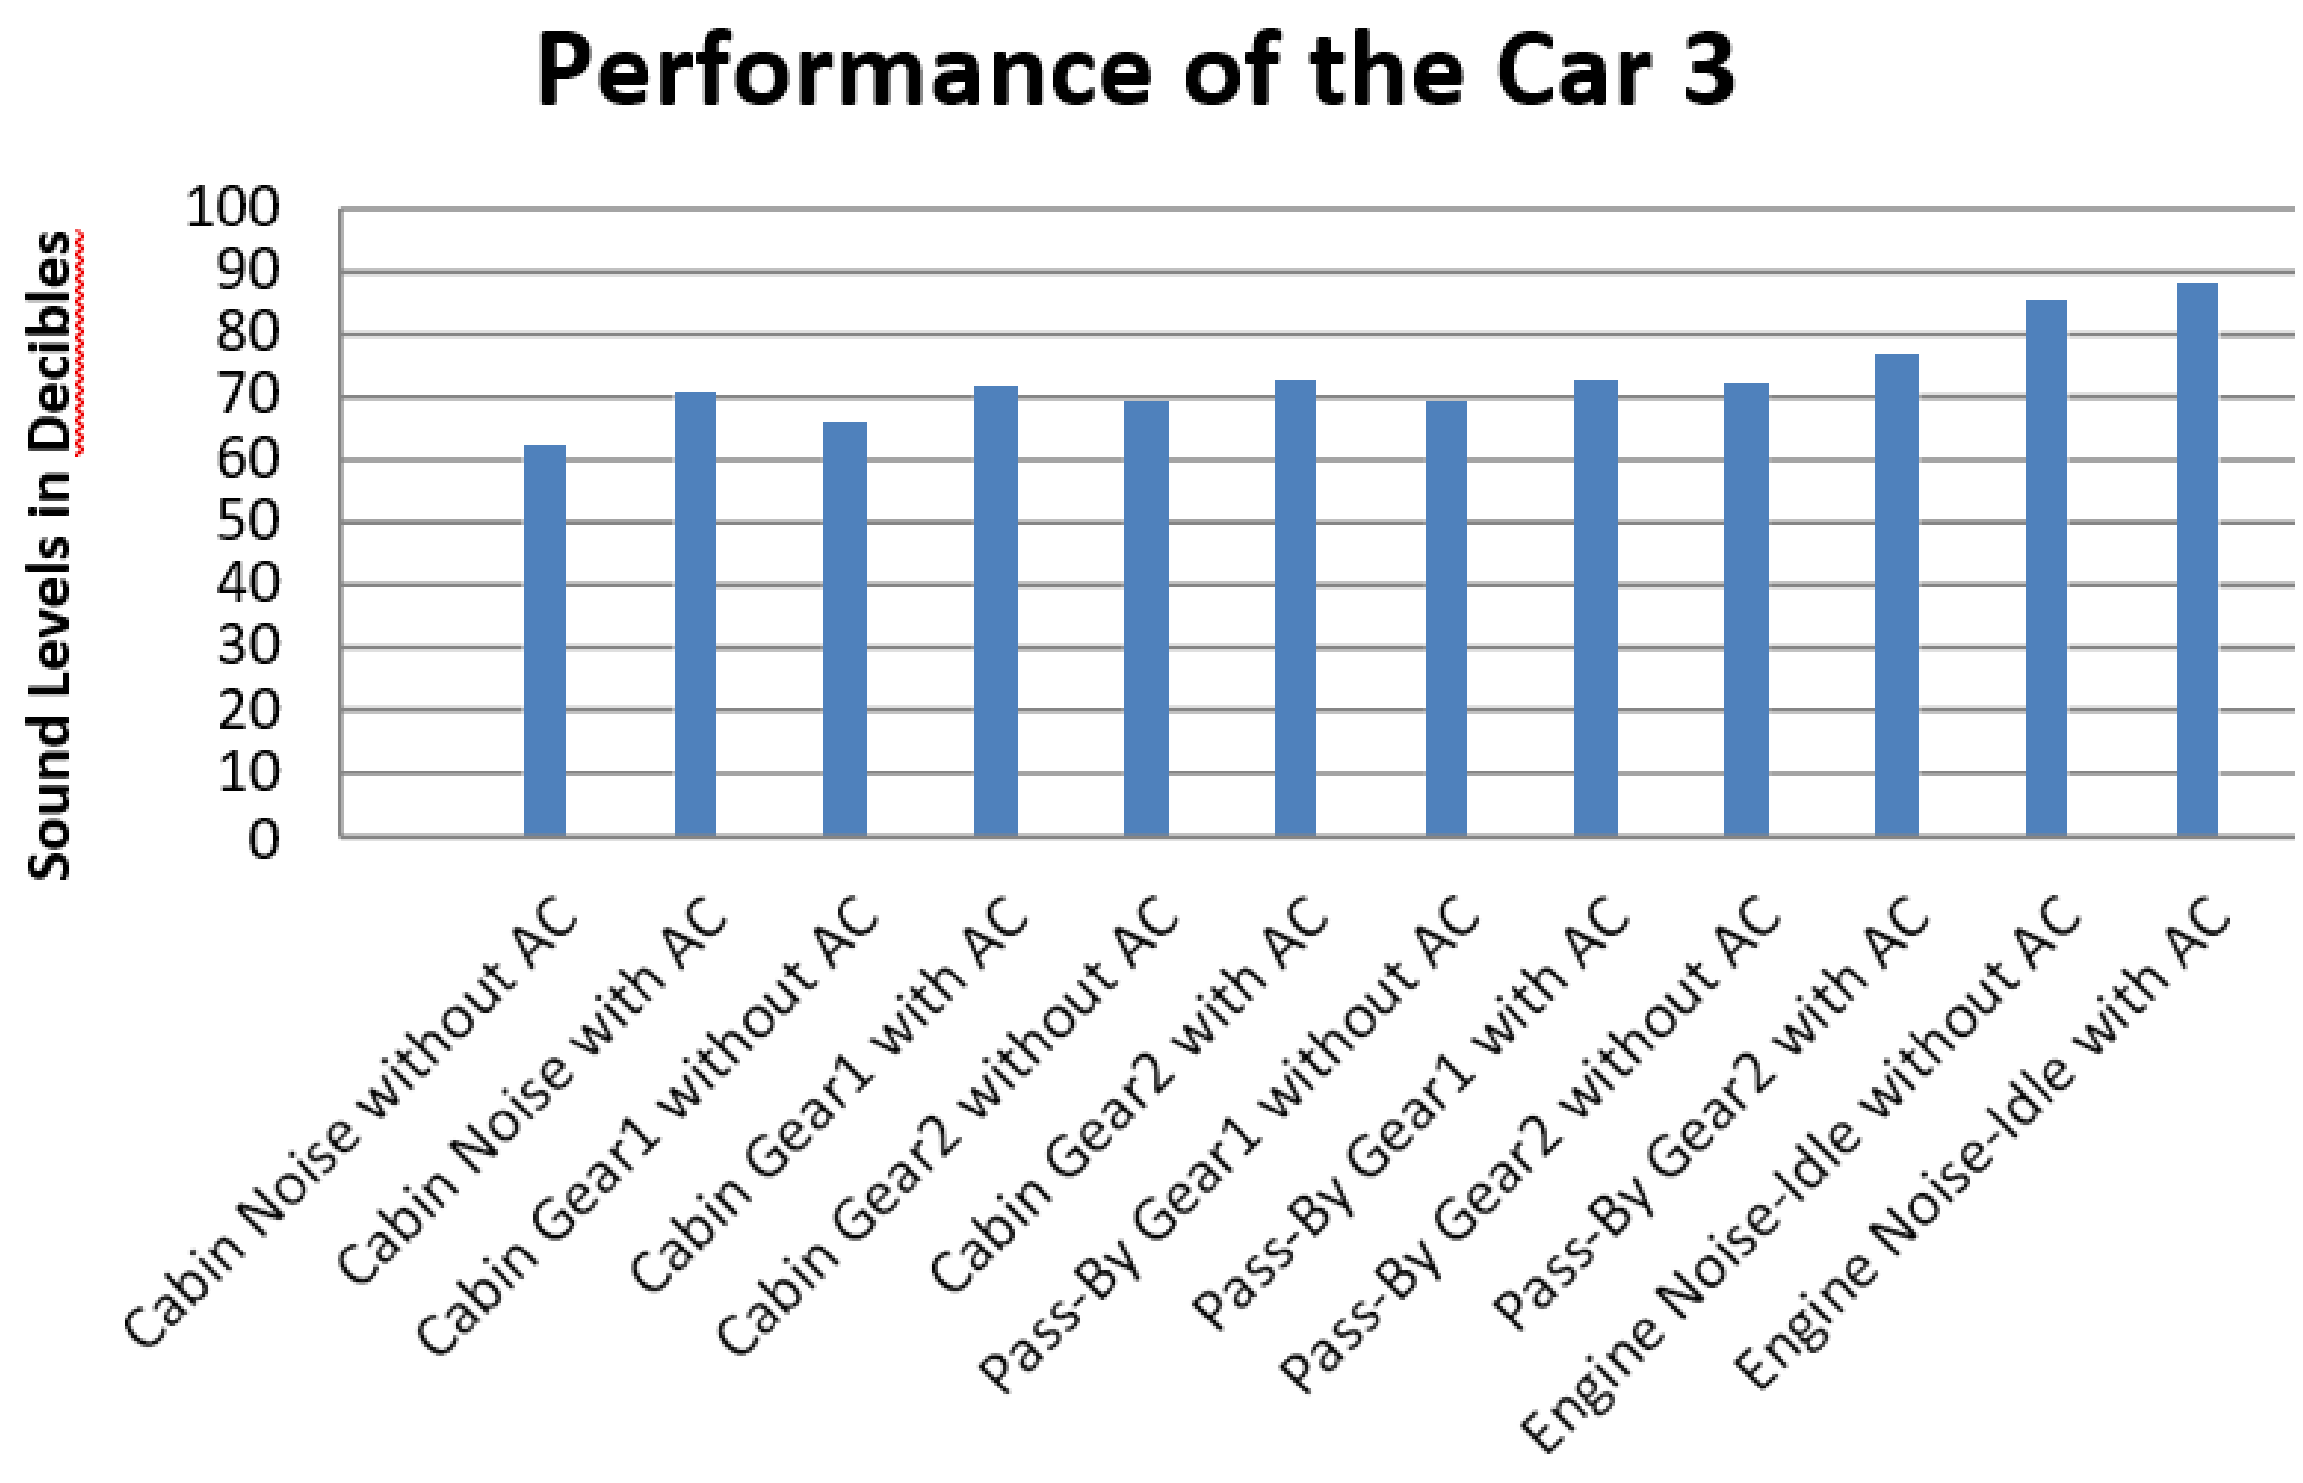
Figure 3: Sound level of Car 3 for all the conditions

2. The cooling system problem can be identified by simply recording the sound levels at idle conditions. In Car 3 the problem of cooling system was identified due to higher sound level and during verification it has been identified that the cooling system was not serviced for a long time.

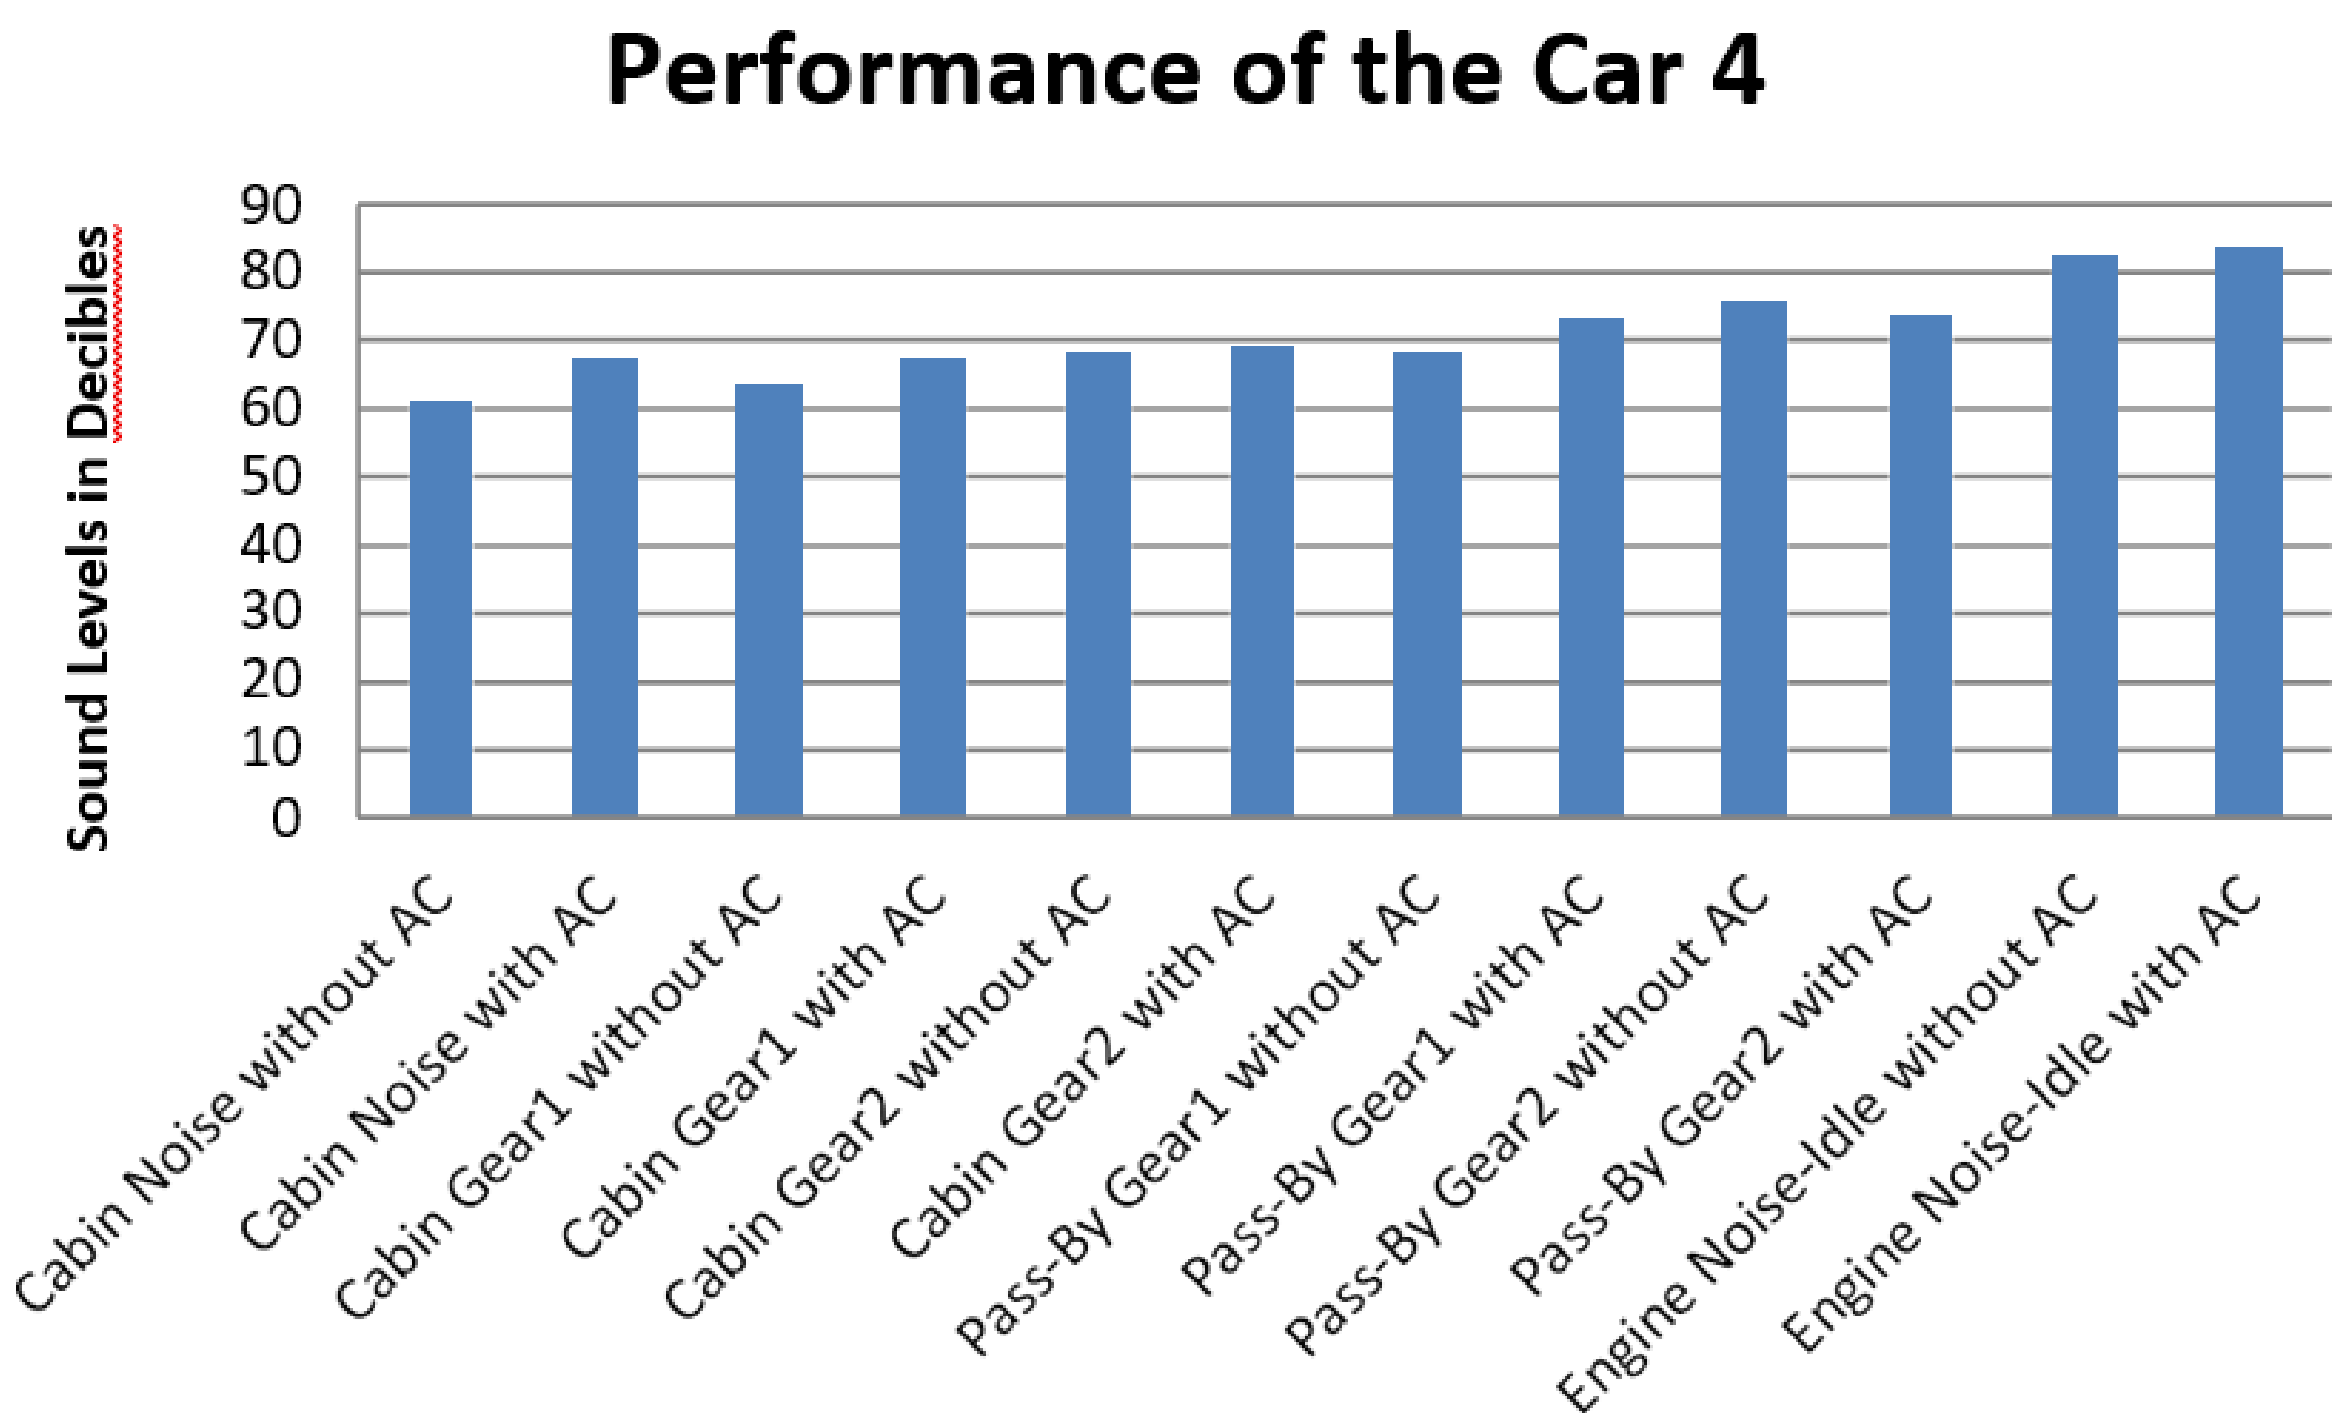
Figure 4: Sound level of Car 4 for all the conditions

4. To keep the car in the good shape it is recommended to get vehicle serviced as prescribed by the manufacturer. In feedback analysis the Car 4 has shown remarkable levels of sound even after driven for more than 100000 kms just because of strict regime followed by his owner for the service.
